# **INDOOR AIR QUALITY ASSESSMENT**

**Cerebral Palsy of Massachusetts  
Options Program  
30 Taunton Green, Unit 8  
Taunton, Massachusetts 02780**

Prepared by:  
Massachusetts Department of Public Health  
Center for Environmental Health  
Emergency Response/Indoor Air Quality Program  
December 2005

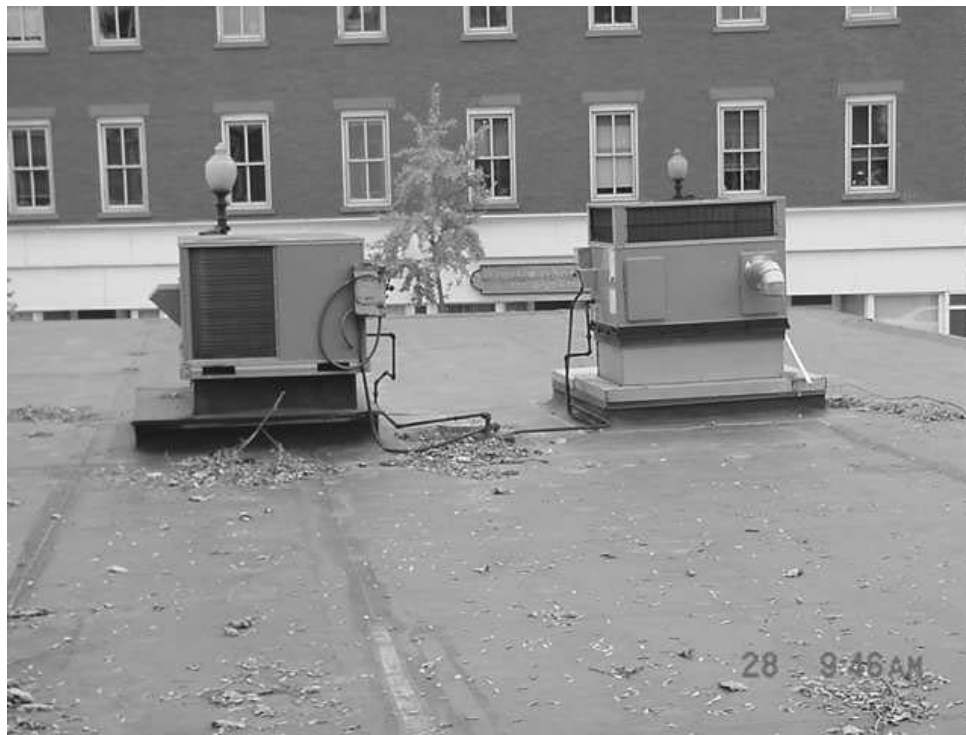
**Picture 1**

The heating, ventilating and air conditioning (HVAC) system consists of rooftop air handling units (AHUs) (Picture 1), which provides conditioned outside air through ducted ceiling vents (Pictures 2 and 3). Air is returned to the AHUs by ducted ceiling-mounted return vents (Pictures 4 and 5). This system was operating throughout the building during the assessment. Thermostats that control the HVAC system have fan settings of “on” and “automatic”. Thermostats were set to the fan “on” setting (Picture 6) providing continuous airflow, which is recommended by the MDPH. The “automatic” setting on the thermostat activates the HVAC system at a preset temperature. Once the preset temperature is reached, the HVAC system is deactivated.

**Rooftop AHUs**

1. Increase the percentage of fresh air supplied by the HVAC as a means to improve air exchange.
2. Consult a ventilation engineer concerning re-balancing of the ventilation systems. Ventilation industrial standards recommend that mechanical ventilation systems be balanced every five years (SMACNA, 1994).

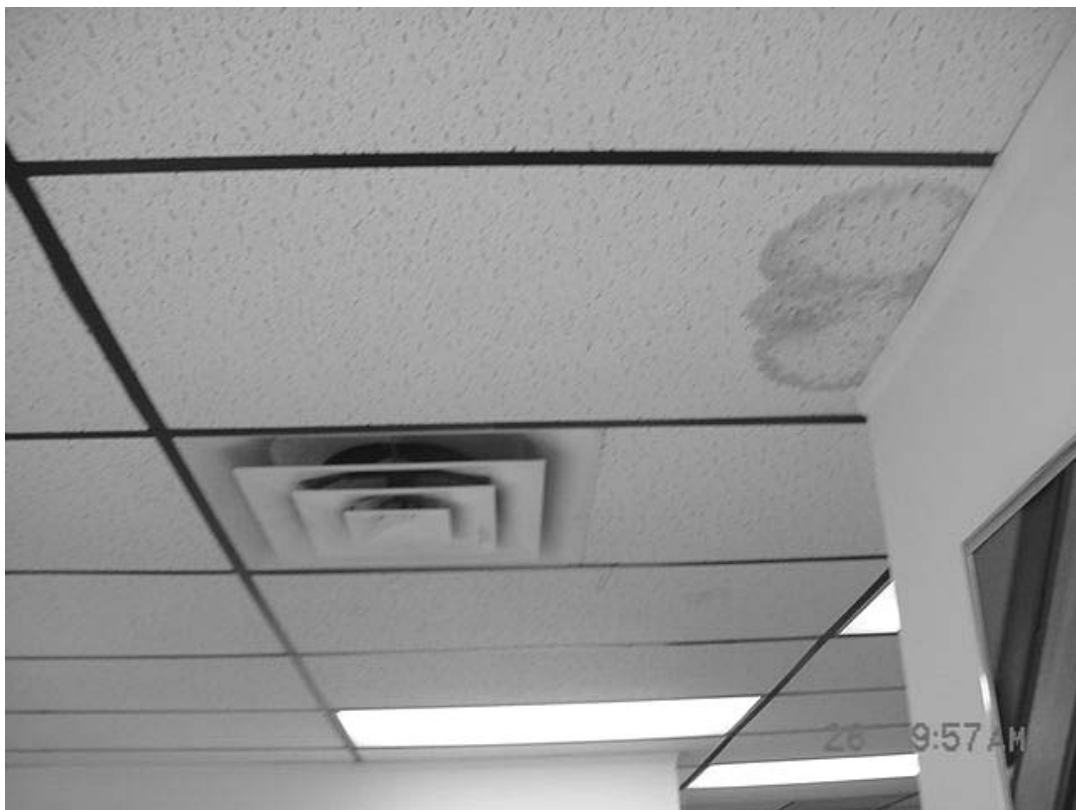
**Picture 2**

**Ceiling-Mounted Air Diffuser, Note Stained Ceiling Tile**

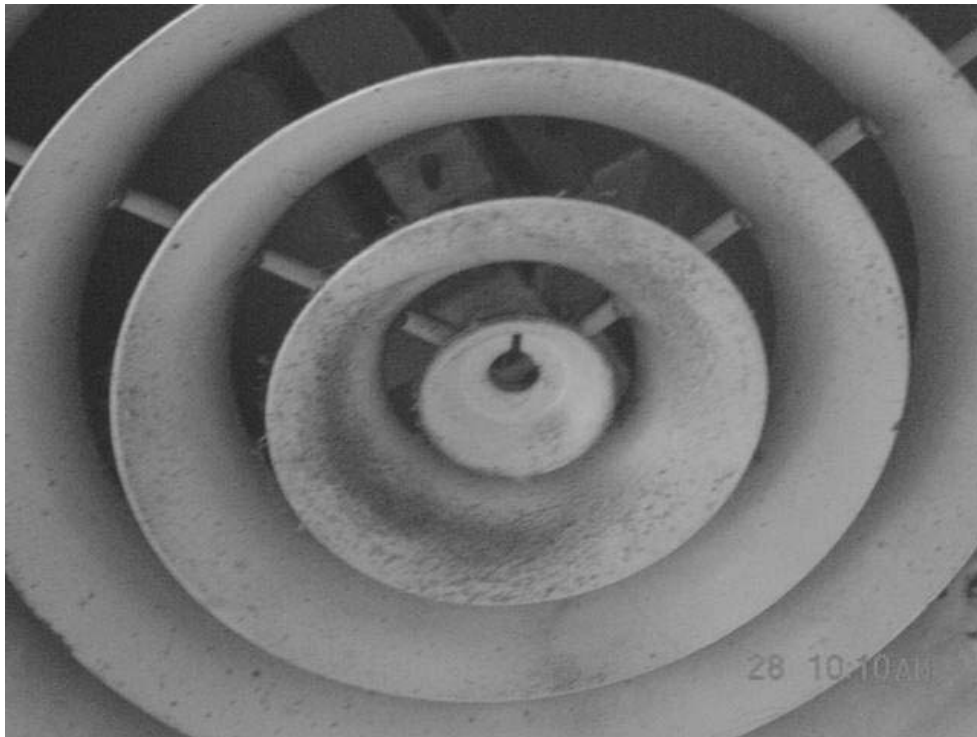
**Picture 3**

**Ceiling-Mounted Air Diffuser, Note Dust Buildup**

9. Clean and disinfect dehumidifiers/humidifiers as per the manufacture's instructions to prevent microbial growth.
10. Clean supply/return vents periodically of accumulated dust.

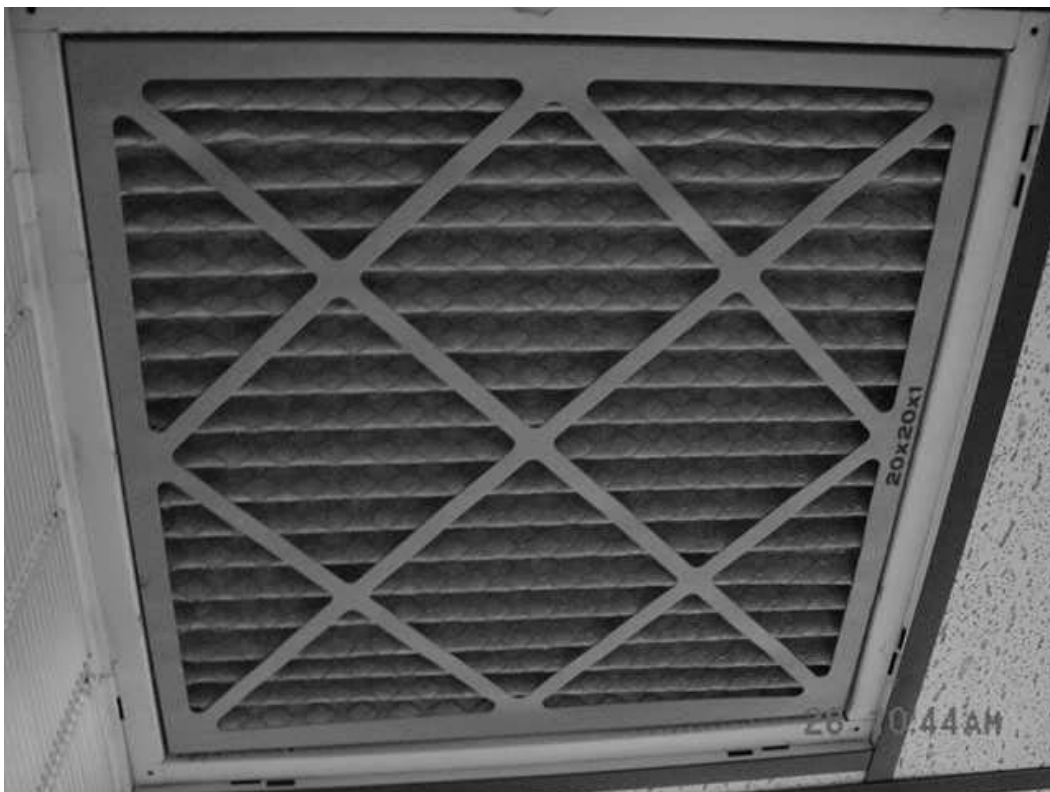
**Picture 4**

MDPH staff inspected HVAC filters, which were located in the ceiling-mounted return vents and inside rooftop AHUs. The filter installed in the main return vent of the OP was a high-efficiency pleated filter (Picture 4). The filters installed in the AHUs were of a type that provides minimal filtration (Picture 13). In order to decrease aerosolized particulates, higher efficiency, disposable filters can be installed in the AHUs. The dust spot efficiency is the ability of a filter to remove particulates of a certain diameter from air passing through the filter. Filters that have been determined by ASHRAE to meet its standard for a dust spot efficiency of a minimum of 40 percent would be sufficient to reduce airborne particulates (Thornburg, 2000; MEHRC, 1997; ASHRAE, 1992). Note that increased filtration can reduce airflow produced through increased resistance (called pressure drop), which may be occurring due to high efficiency filters installed in the central return vent, as opposed to in the AHUs. Prior to any increase in filtration, AHUs should be evaluated by a ventilation engineer to ascertain whether they can maintain function with more efficient filters. A portable air purifier was also observed in use. These units also have filters that should be cleaned or changed as per the manufacture's recommendations.

**Central Return Vent with High Efficiency Pleated Air Filter**

3. Consider upgrading filters in AHUs to higher efficiency pleated air filters instead of at return vents to reduce pressure drop and improve exhaust capabilities. Prior to any increase in filtration, AHUs should be evaluated by a ventilation engineer to ascertain whether they can maintain function with more efficient filters.

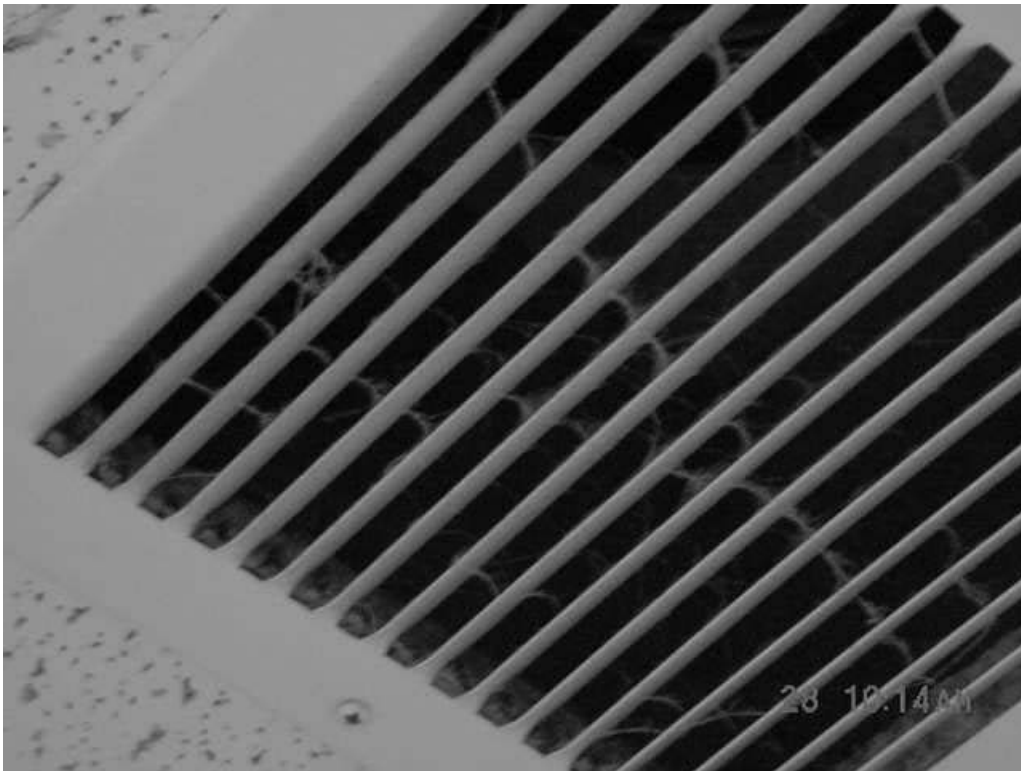
**Picture 5**

**Ceiling-Mounted Return Vent in Office**

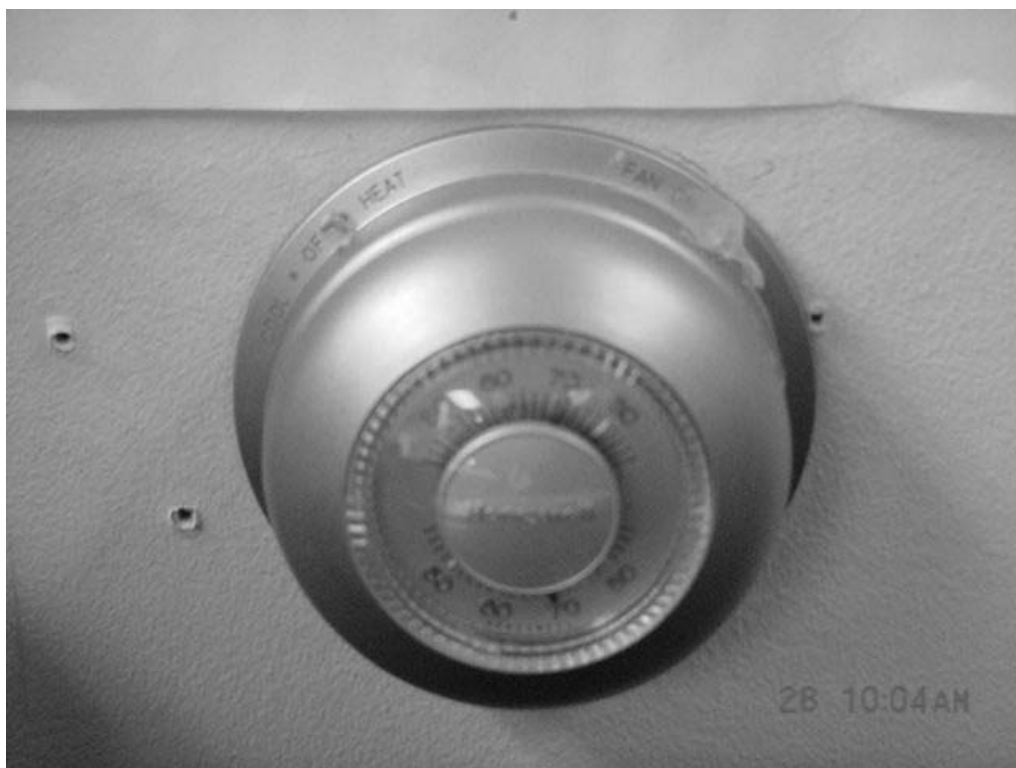
**Picture 6**

**Thermostat for HVAC System**

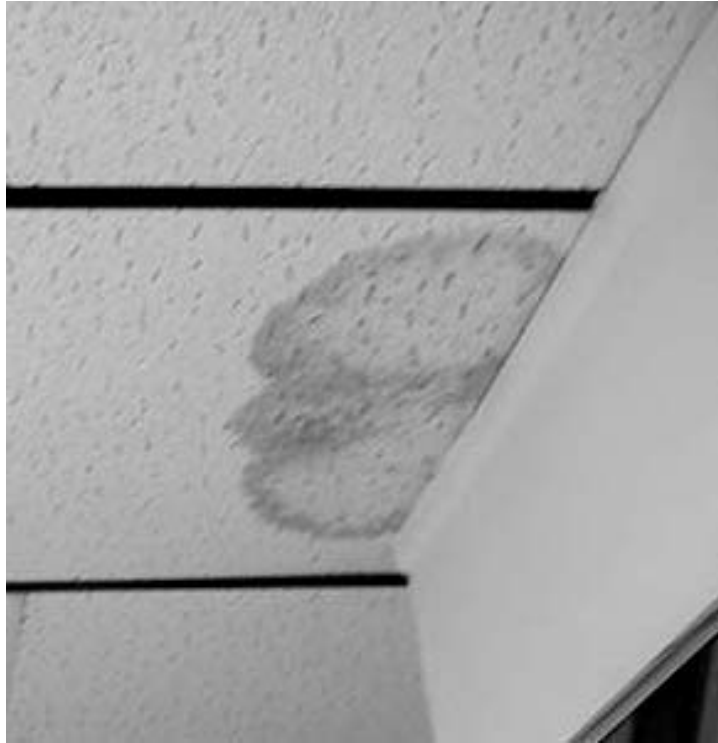
**Picture 7**

A number of areas had water-damaged ceiling tiles (Picture 7). Occupants reported that ceiling tiles became damaged as a result of roof leaks that have since been repaired. Water-damaged ceiling tiles can provide a source of mold and should be replaced after a leak is discovered and repaired. MDPH staff removed ceiling tiles in a number of areas to examine conditions above the ceiling plenum. All areas appeared dry, and no visible mold growth and/or associated odors were observed/detected on the day of the assessment. In

addition, MDPH staff conducted moisture testing of water damaged ceiling tiles. In order for building materials to support mold growth, a source of water exposure is necessary. Identification and elimination of water moistening building materials is necessary to control mold growth. Materials with increased moisture content *over normal* concentrations may indicate the possible presence of mold growth. All water damaged ceiling tiles tested were found to have low (i.e., normal) moisture content (Table 1) at the time of the assessment.

**Water Damaged Ceiling Tile**

5. Continue to repair any water leaks as they may occur, and replace any remaining water damaged ceiling tiles. Examine the areas above and behind these areas for mold growth. Disinfect areas of water leaks with an appropriate antimicrobial.

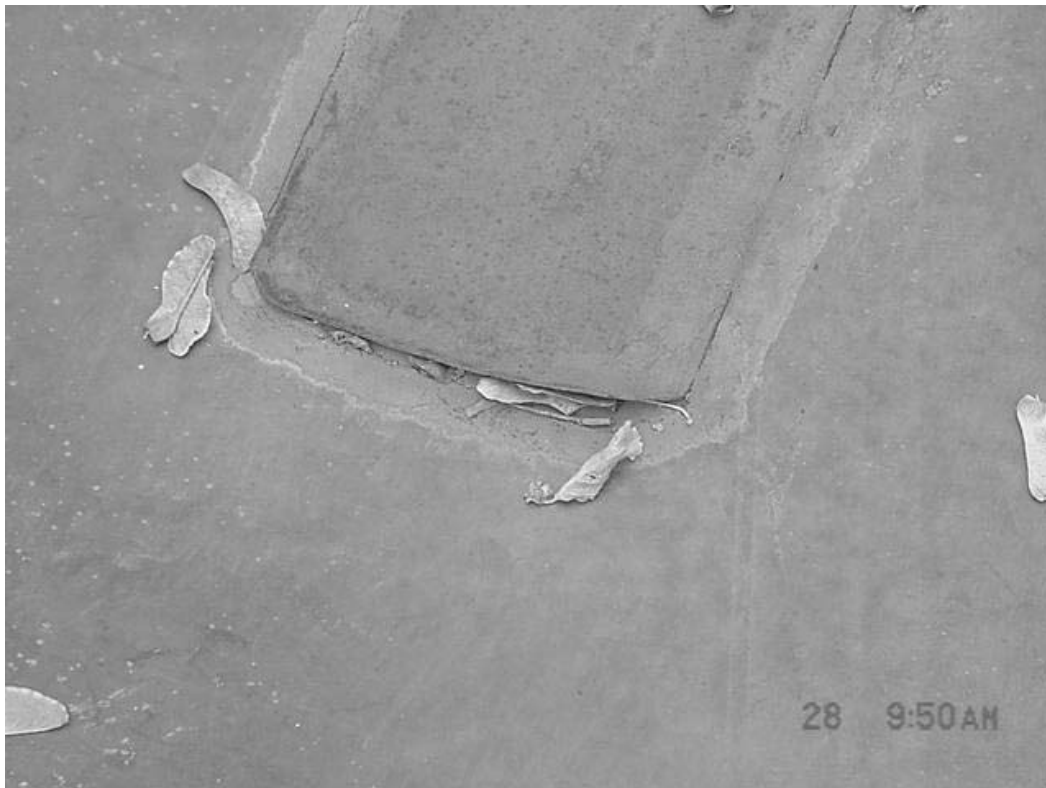
**Picture 8**

Conditions on the roof were examined. Several patches for previous roof repairs were evident. One patch had become loose and leaves and other debris were observed underneath the patch (Picture 8). Breaches in seals of patches can allow water infiltration under the roof membrane. Roof drains were also observed to be clogged with leaves (Picture 9) from branches that overhang the roof (Picture 10). Clogged drains, accumulated leaves and debris can hold water on the roof where repeated freezing and thawing during winter months can damage the roof membrane and lead to water penetration.

**Loose Roof Patch With Leaves Underneath**

6. Trim tree branches to prevent any from overhanging above the roof. Inspect and clear debris from roof drains regularly. Reseal roof patch shown in Picture 8.

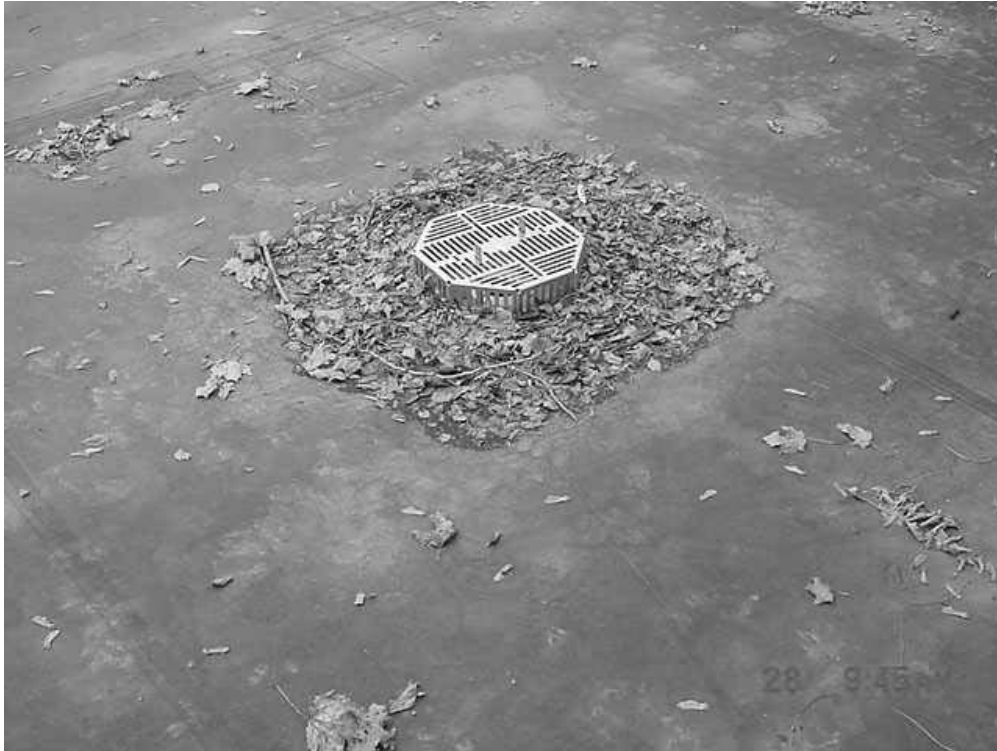
**Picture 9**

**Clogged Roof Drain**

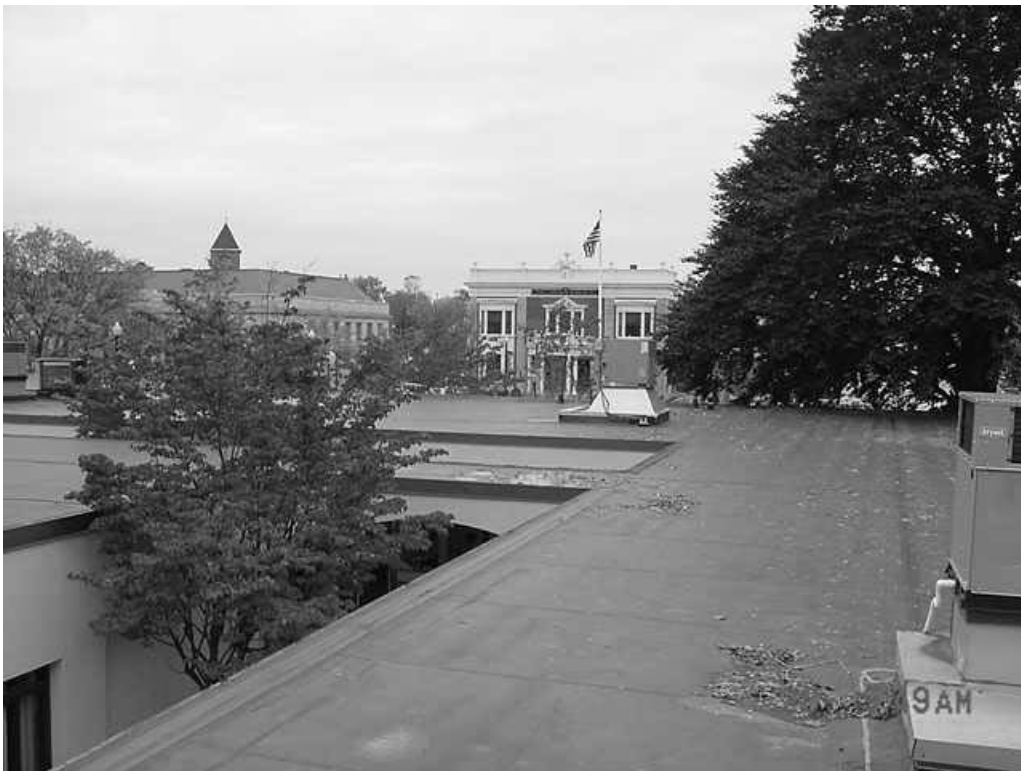
**Picture 10**

**Trees Overhanging Roof**

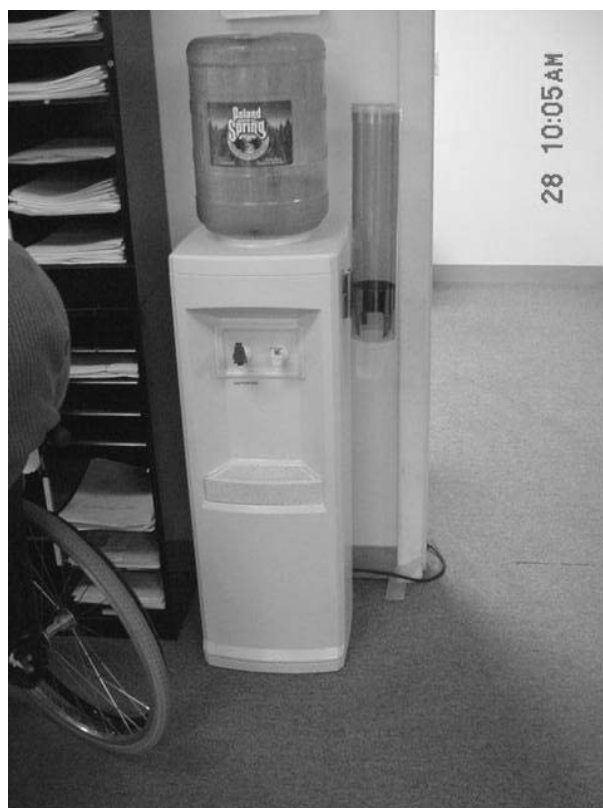
**Picture 11**

A water cooler was located over carpeting (Picture 11). Water spillage or overflow of cooler catch basins can result in the wetting of the carpet. In addition, some of the coolers had residue/build-up in the reservoir. These reservoirs are designed to catch excess water during operation and should be emptied/cleaned regularly to prevent microbial and/or bacterial growth.

7. Ensure plants have drip pans. Examine drip pans periodically for mold growth and disinfect with an appropriate antimicrobial where necessary.
8. Relocate or place tile or rubber matting underneath water coolers in carpeted areas. Clean and disinfect reservoirs as needed to prevent microbial growth.

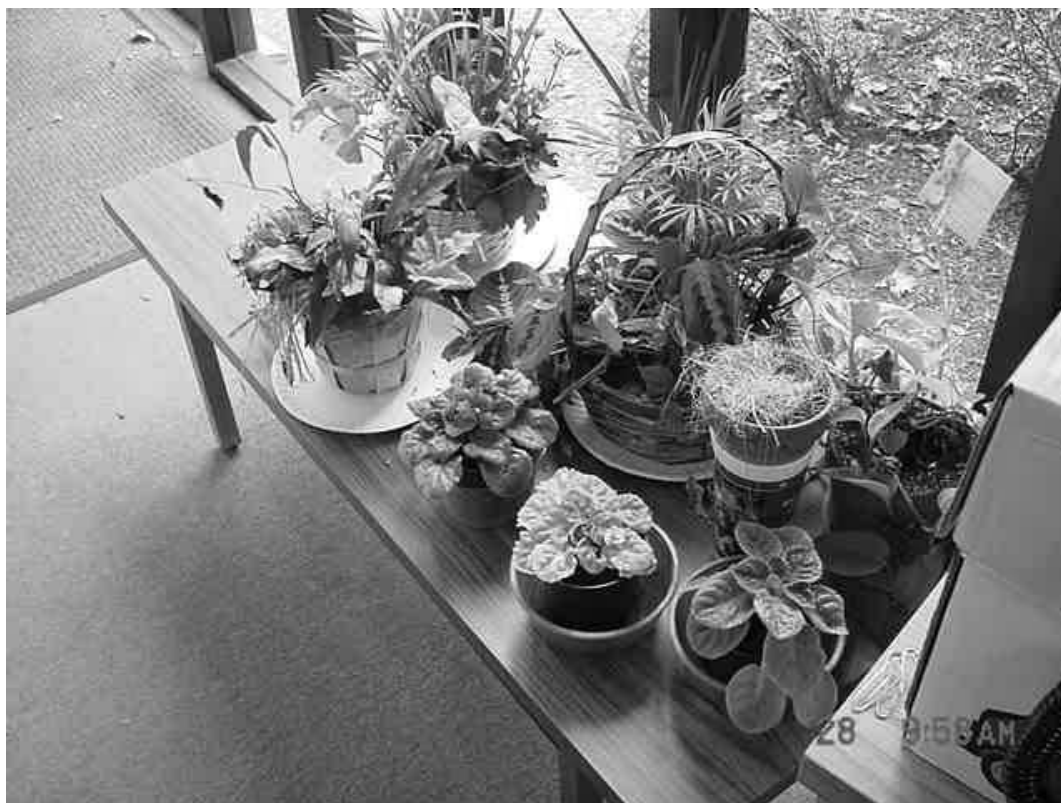
**Picture 12**

Plants were noted in several a few areas. Some plants were placed on paper plates (Picture 12). Plants should be properly maintained and equipped with drip pans. Plants should be located away from ventilation sources to prevent aerosolization of dirt, pollen or mold. Plants should not be placed on porous materials, since water damage to porous materials may lead to microbial growth.

**Plants on Paper Plates**

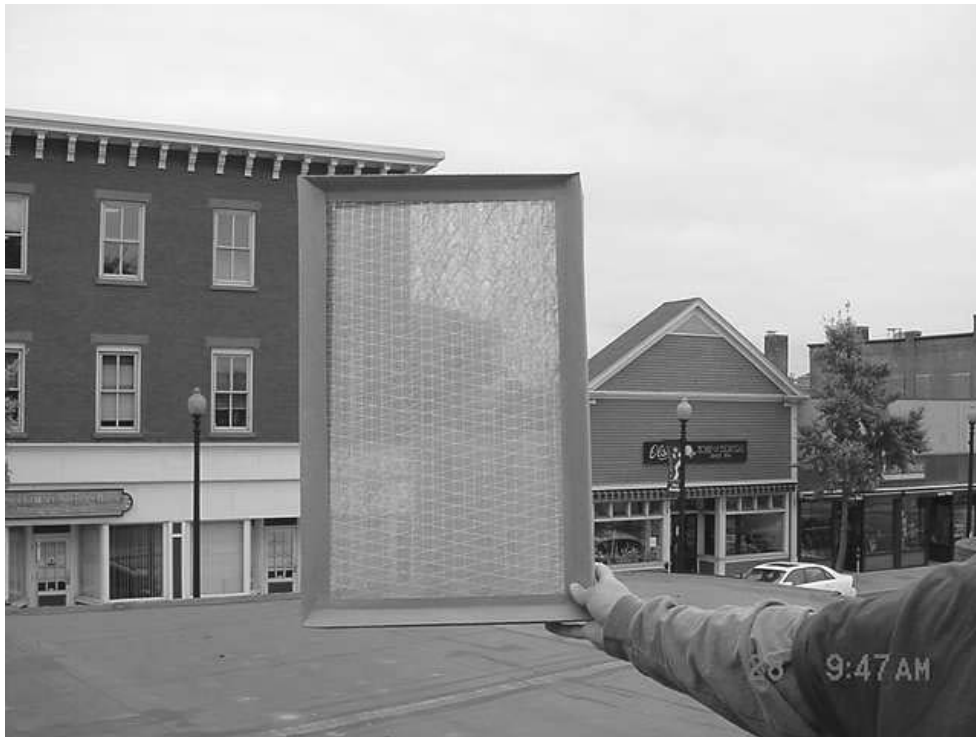
**Picture 13**

**Fibrous Mesh Filter Installed in Rooftop AHU**
